AFML-TR-78-160
Volume I

COST EFFECTIVE REPAIR TECHNIQUES FOR TURBINE AIRFOILS

GENERAL ELECTRIC COMPANY

NOVEMBER 1978

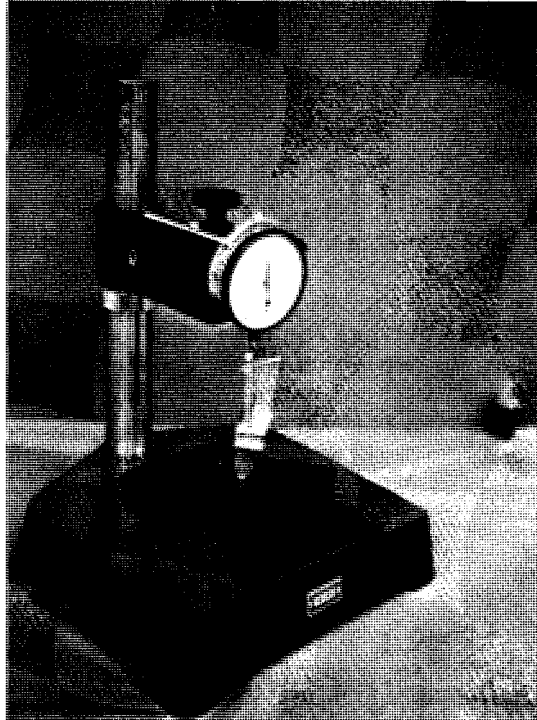
Evaluation of the fixture shown in Figure 40 used to determine the ADB joint gap on the mini-bonded blade showed that repeatability was not obtainable when a 'standard' blade was subjected to repeated blade height measurements.

Figure 40. Inspection Fixture Used to Determine
ADB Joint Gap on Mini-Bonded Blade Tips

Since on the initial run, the bond gap measurements were made using this old fixture configuration, confidence in the accuracy of these measurements is lacking and may account for the high fallout of blades rejected for exceeding the bond gap dimensional limit. To verify the accuracy of the new fixture several blades which had cap to tip bond gaps measured in the fixture using both the old and new configuration were cut to show the cross sections at three measurement points on the joints (see Figure 41) and photomicrographs were made.

Modifications of the fixture were made and resulted in a constant position of each blade in the fixture such that repeatable blade height measurements could be made.

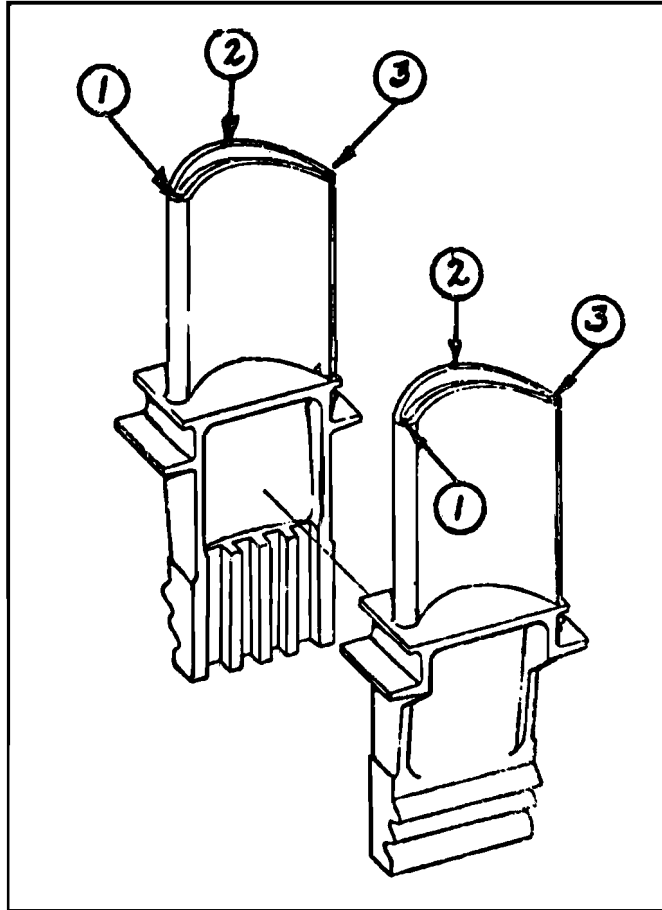
Figure 41. Bond Gap Measurement Locations, Lead and Trail Blades

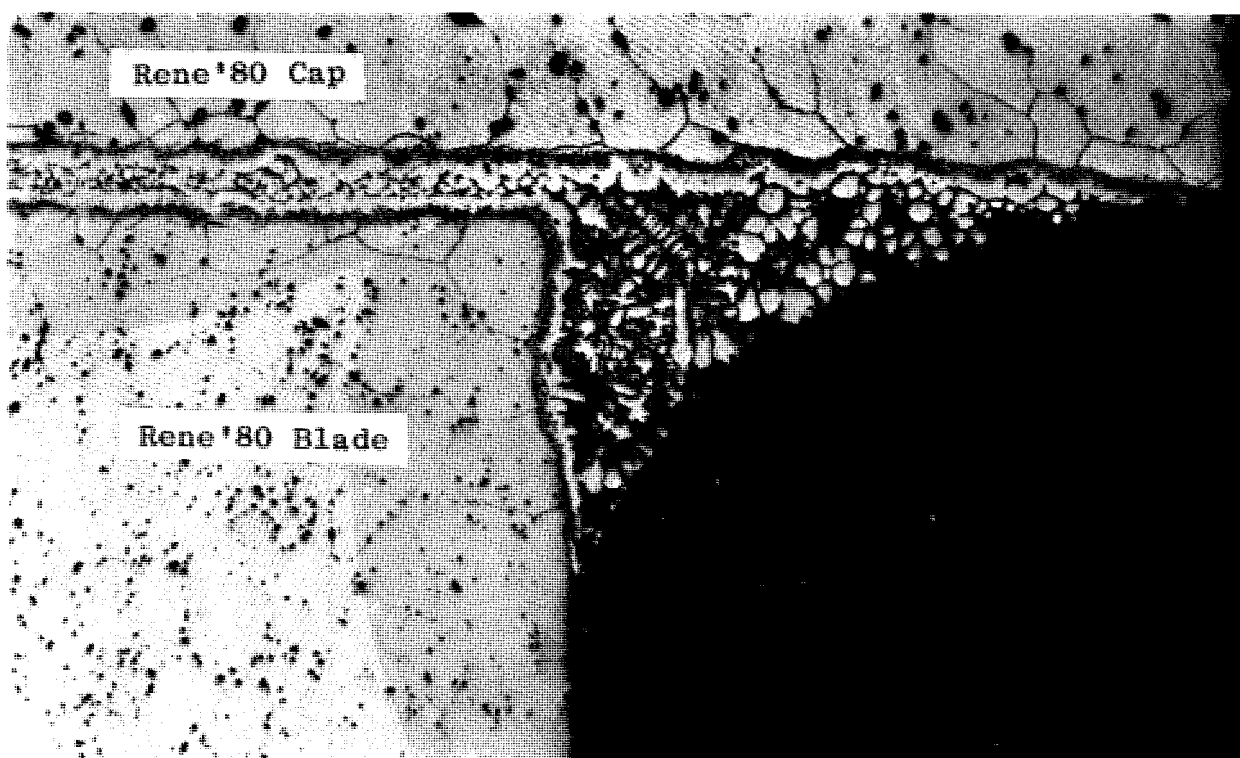
Figures 42 and 43 show a typical joint in the as-bonded condition after being run through the diffusion cycle. Bond gap measurements from photomicrographs of the joint are more easily read in the as-bonded condition than after the post diffusion cycle. However, it is useful to see the high quality of the joint after the diffusion cycle has been run. From these photomicrographs the true bond gap can be measured using 100X magnification of these joints. As a result of this comparison it was shown that the new configuration of the fixture accurately measured the true bond gap. Thus, this new fixture configuration shall be used on future blade runs through the pilot line. Unfortunately blades already processed using the original fixture cannot have the bond gap re-measured using this fixture due to the technique involved.

Figure 42. Blade to Cap Joint As-Bonded Prior to a Heat/Diffusion Cycle

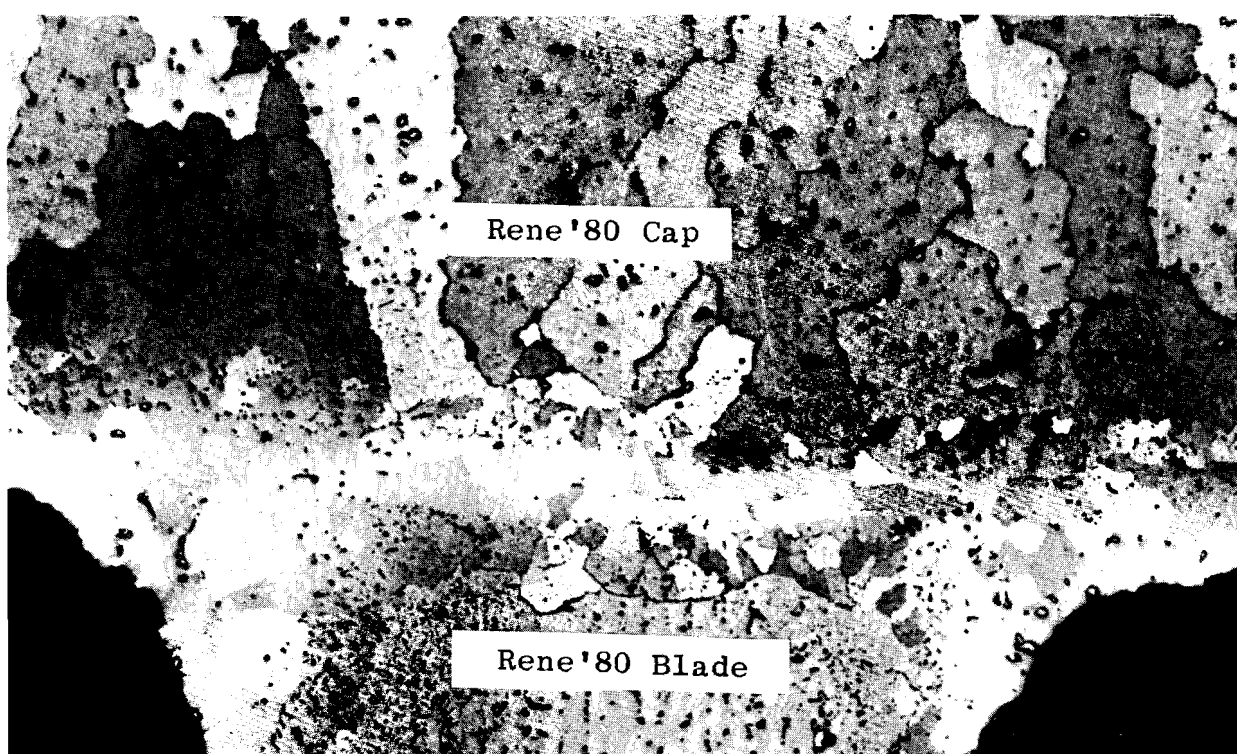
Figure 43. Blade to Cap Joint After a Heat Treat/Diffusion Cycle
